GRUNDFOS

WHITE PAPER

Pump Wear and Wear Rings

by Steve Wilson

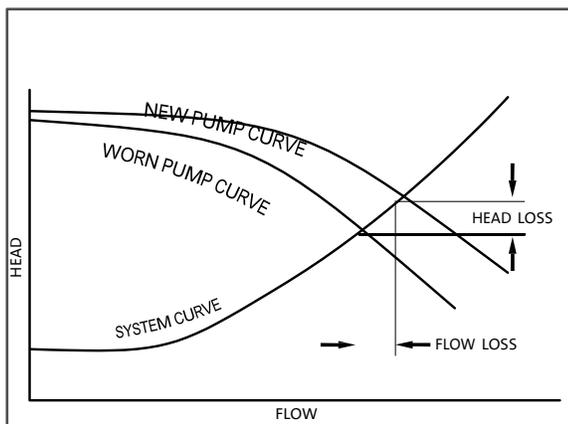
The impact of hydraulic performance is shown in *Figure 1*.

Figure 1. Impact of wear on performance

The actual operating points will of course vary with different pump and system curves, but the basic relationship remains the same

- The pump draws the same amount of power in its worn state as in its new state. It is actually “pumping at design point.” Unfortunately, the system doesn’t see this, since a portion (the exhibited “performance loss”) is recirculated through the gap between the impeller and the volute. The user is paying for this recirculation in utility bills.

- The increase in recirculation directly contributes to loss of efficiency. Since efficiency is a ratio of output work against input power, and since output work (flow and head) is less with the same amount of input power, efficiency is lower. In addition, the increased suction turbulence and “pre-rotation” cause negative suction conditions which will drive efficiency down.

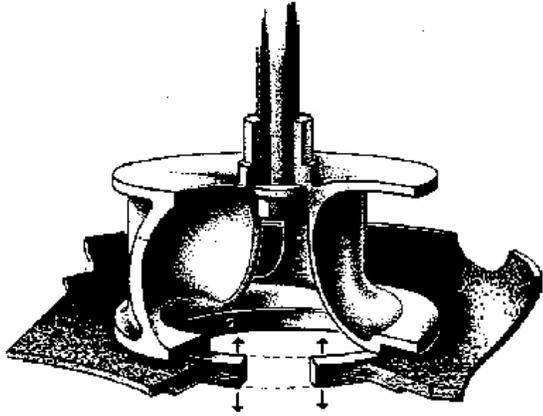
One solution is to use adjustable wear rings. By allowing adjustment directly to the ring in the front of the pump, the frame adjustment can be used to assure correct dimensions in the rear. An adjustable wear ring is shown in *Figure 2*.

Figure 2. Adjustable wear ring

As previously discussed, adjusting the position of a wear ring or wear plate through axial movement of the shaft may pose the problem of disrupting the “rear” of the impeller in the case.
